One Fuel Sender Failure and How to Repair It

By Bill Noble, Santa Monica, CA ©

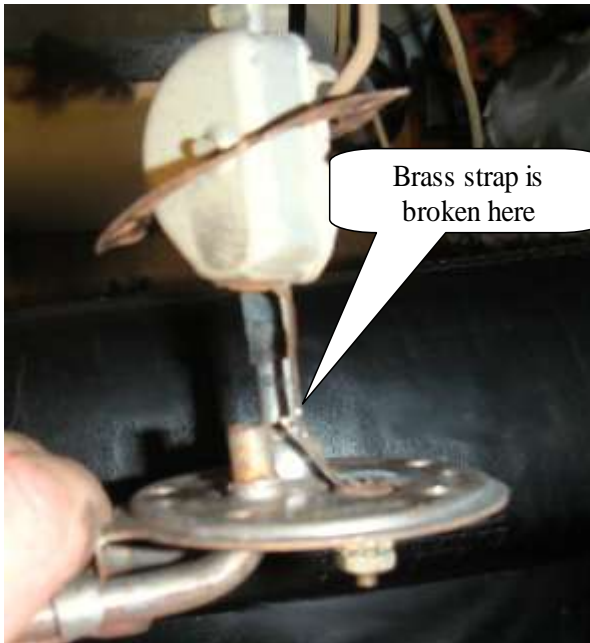
With the tank free of the car, remove the Phillips head screws and remove the sender. [Photo 1](#) shows what I found. The brass strap that connects the sender to the terminal had broken in half – I presume this is due to vibration induced stress fatigue, I can't imagine any other mechanism. Since this happened to me, there is a reasonable chance that other cars with a similar sender will encounter the same problem, so here's how to fix it.

Photo 1 – broken strap on fuel sender

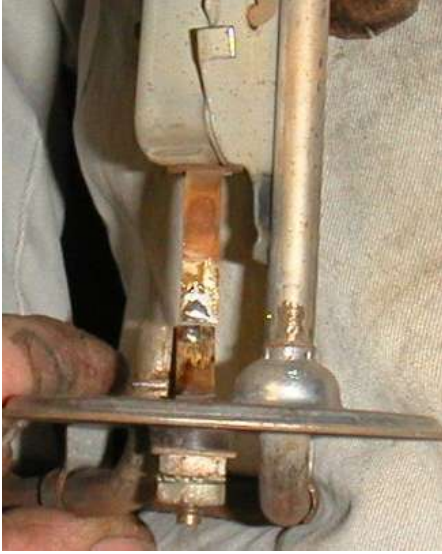
Photo 2 –

Tinning the strap on either side of the break – this is not good enough yet, after this photo, I cleaned it some more and tinned it again. Note that if you are soldering in your lap like I was in this photo, wear thick pants – the burns from solder dropping on your skin are 3rd degree burns, you don't want to experience that if you can avoid it.

First, clean the strap for about ¼ inch on either side of the break until it is shiny. Then tin both sides using electronics type (rosin core) solder (see [photo 2](#)). You want to tin first so you can be sure that the solder is adhering well and you will get a connection that is electrically good and has good mechanical strength.

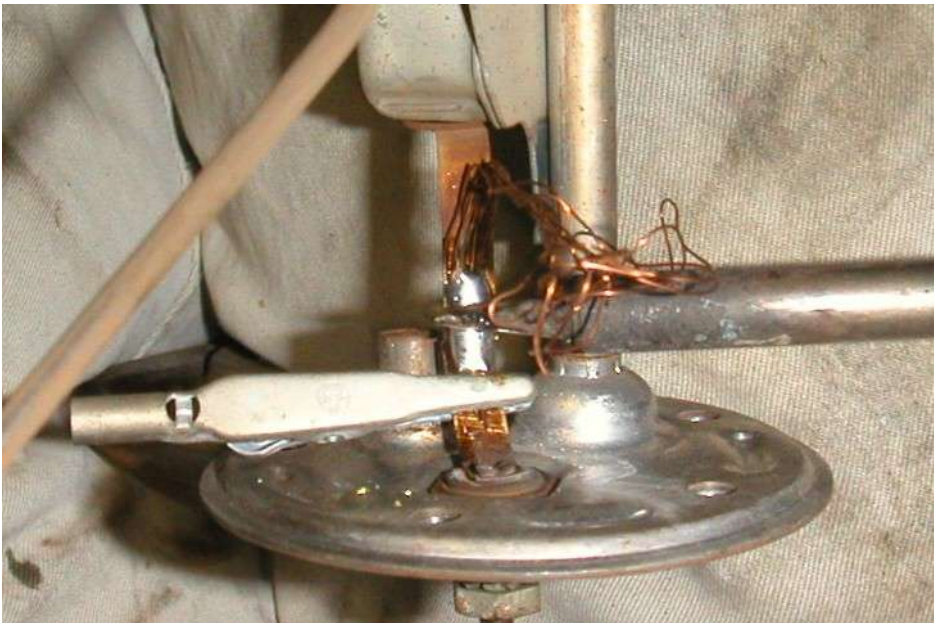
Photo 3 – Soldering a length of stranded wire in place, using an alligator clip as a clamp

Once the strap is tinned, clamp a short length of stranded wire to the strap, and solder it in place ([photo 3](#)). You need to clamp it with an alligator clip or something because otherwise it is likely to move and give you a “cold” solder joint. I used multi-strand wire because if the failure was in fact vibration induced, the multiple strands will not only help dampen vibrations but will also not support crack propagation like a single strand of wire. The current through the sender is very small, you could use thinner wire and less of it, but then you are subject to mechanical failure.

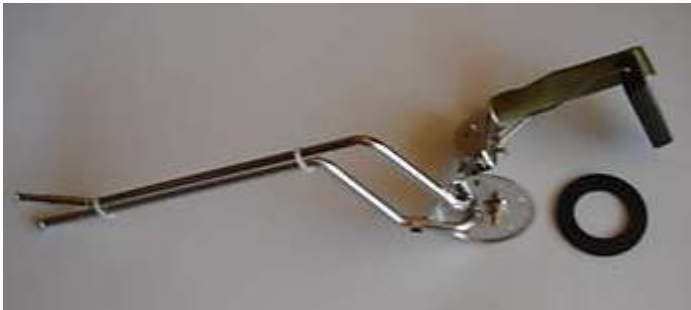
Figure 5 – new fuel sender

Now, in 2012, there are reproduction fuel senders available, made out of stainless steel – I purchased one of them for approximately \$60, and following the removal/installation procedure above, I installed it. [Figure 5](#) shows the new sender, [figure 6](#) shows the original sender. The new sender came with a neoprene gasket, and is made out of stainless steel (mostly). The float is a black plastic material. The original sensor was made from lead plated steel (mostly) with some brass, the float material is treated cork. The gasket was cork.

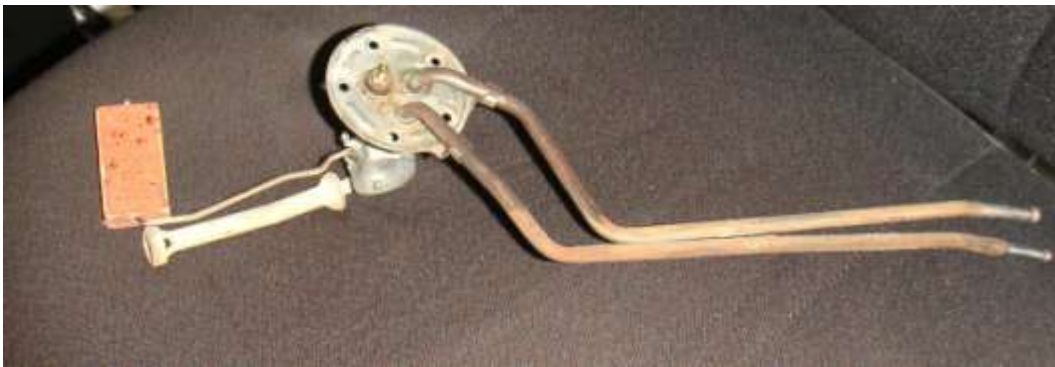
Figure 6 – original fuel sender

one lead to the metal structure – I measured about 60 to 100 ohms no matter what position the float was in – that is not right, in the empty position the resistance should be an ohm or two. I didn't think of making a plot of resistance versus angle with the new unit until now, so sorry, you don't get that piece of information.

Clearly, something is wrong though if the resistance doesn't vary with the float angle, so I carefully pried back the tabs and looked inside the element that contains the resistance winding (that is the sort of rectangular thing next to the text callout in [figure 1](#)). Sadly, I didn't take a photo of what was inside, but what I found was some yellowish deposits (presumably from the old fuel vapors), a U shaped piece of brass spring material spot welded to the cross shaft to which the lever attaches, and on the end of the brass U a small contact (presumably phosphor bronze) that was swaged into place.

After quite a lot of messing around, I finally localized the problem to a lack of connection between the phosphor bronze contact and the brass U shaped object – the contact point would rub on the resistance element, but without connectivity to the brass wiper spring, there was no current flow. Once I figured this out, repair was simple – using a fine file, I cleaned up an area on the swaged part of the contact point (the part that doesn't contact the resistance wire) and I cleaned up some of the brass spring element near the contact point, and then using my soldering iron, I soldered the two areas together so that there was an electrical connection again. Now the original unit works fine. I believe what happened is that some kind of corrosion built up at the mechanical interface, and that the corrosion (or organic material deposits from the fuel) insulated the contact from the spring.

So, if you choose to repair your fuel sender, also remember to solder the contact to the spring so this doesn't happen to you.
