BOSCH & BOGEN:

An investigation into two radios separated by a quarter-century

6.102 Analog and RF Laboratory
Spring 2010
Massachusetts Institute of Technology

ABSTRACT

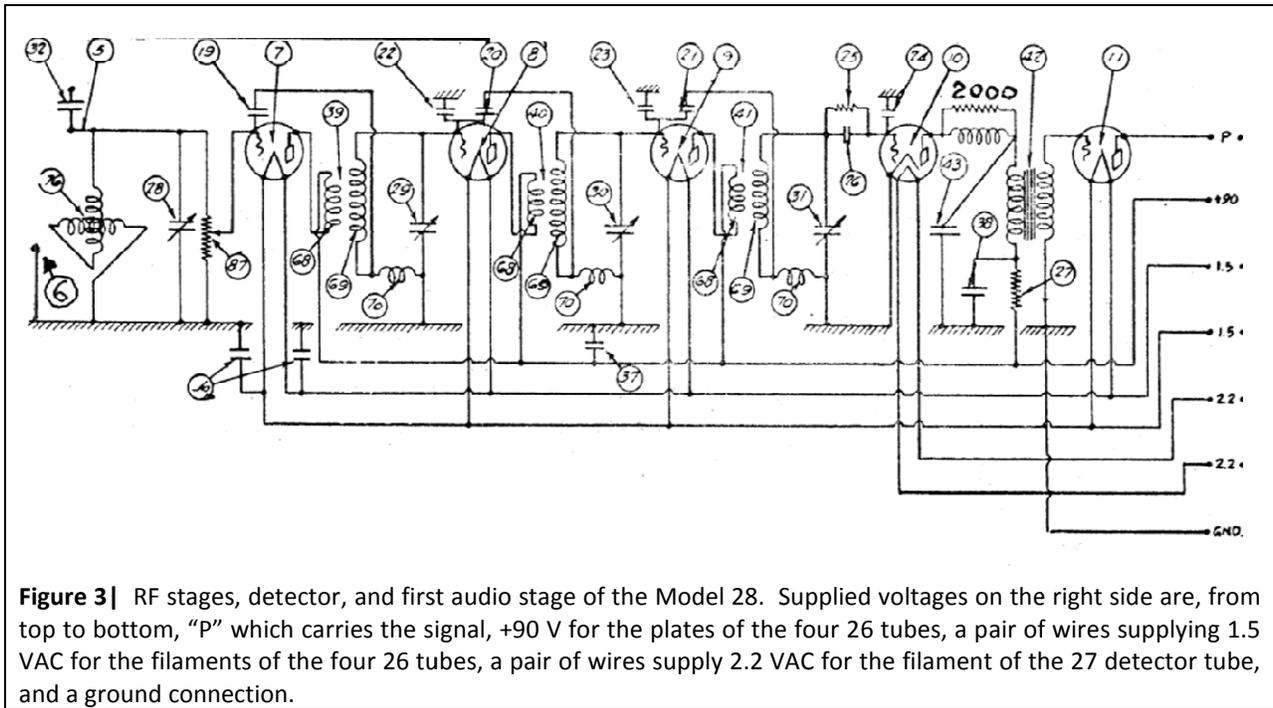
Figure 3 | RF stages, detector, and first audio stage of the Model 28. Supplied voltages on the right side are, from top to bottom, “P” which carries the signal, +90 V for the plates of the four 26 tubes, a pair of wires supplying 1.5 VAC for the filaments of the four 26 tubes, a pair of wires supply 2.2 VAC for the filament of the 27 detector tube, and a ground connection.

Front-End: As shown in Figure 3, an antenna feeds the RF signal into the front-end of the circuit, which is composed of a parallel RLC circuit, with the “C” portion being the first ganged tuning capacitor, the “L” portion being a varicoupler composed of two inter-coupled inductors adjustable by a knob on front, and the “R” portion being a 500 k Ω potentiometer used as a volume/gain control by tapping off a portion of the voltage across this resonance circuit and feeding it into the grid of the first 26 tube.

RF Cascade (Tubes 7, 8, and 9 in Figure 3): Seeing as this set is a TRF, the core of the tuning comes from a set of three RF amplifiers/tuners run in series. Each subunit, based around a 26 tube, is almost identical with the other two. They are transformer coupled to one another and are neutralized using assemblies consisting of a pair of metal washers, a mica sheet, and screws. Each circuit is tuned using one of the ganged capacitors.

Detector (Tube 10 in Figure 3): The output of the RF amplifier cascade is fed through a grid-leak composed of a 2.2 M Ω resistor (3 M Ω according to the schematic) in parallel with a 250 nF capacitor. The detector tube is a type 27 with a separate cathode grounded to chassis. While the four 26 tubes used in the circuit have plate voltages of approximately 90 V, the potential drop across the 50 k Ω plate resistor (“27”) results in a 20 V plate potential for the 27 detector tube. This was done because the tube, being used as a grid-leak detector, relies on space-charge accumulation on the grid for biasing, and without a control or suppressor grid present, as is the case in a pentode, the plate voltage must be kept relatively low to avoid stripping electrons off of the grid, ruining the bias.

First Audio (Tube 11 in Figure 3): The output of the grid-leak detector is coupled via an iron-core transformer into the grid of the first audio amplifier stage, built around a 26 triode. The plate signal for this tube is fed out on the “P” wire to the power pack portion of the Model 28.

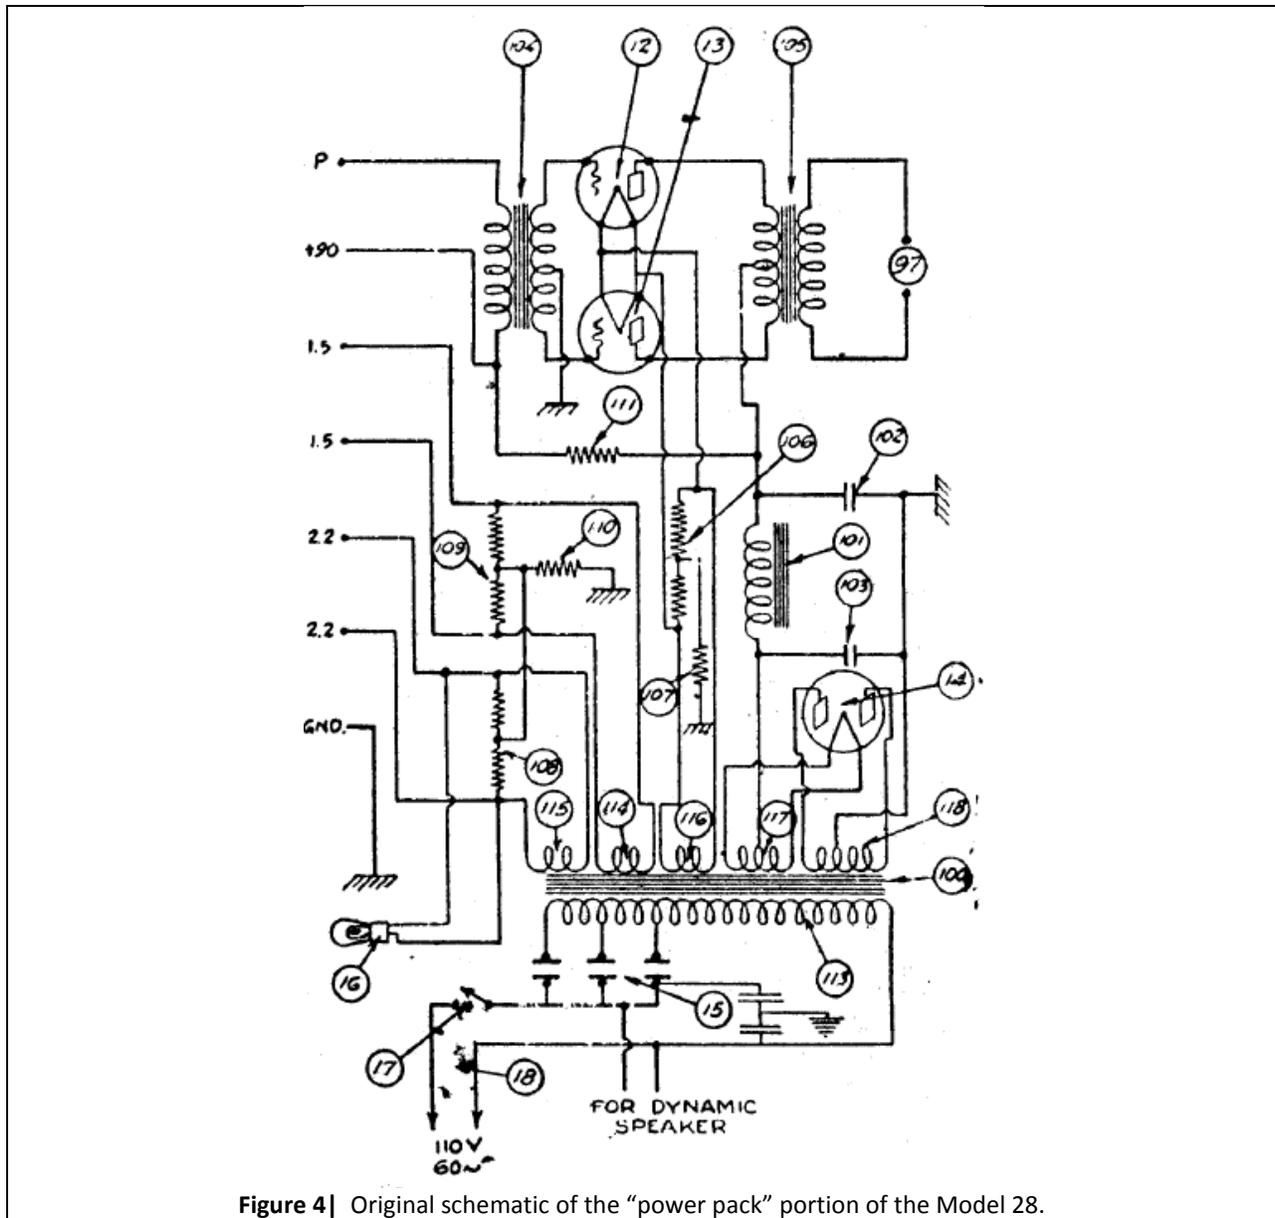
Figure 4| Original schematic of the "power pack" portion of the Model 28.

Power Amplifier (Tubes 12 and 13 in Figure 4): The First Audio stage drives the primary of an iron-core transformer which in turn feeds the grids of a pair of 71A power triodes setup in a push-pull format. Their output supplies the primary of an iron-core output transformer originally intended for high-impedance speakers, but replaced in the restoration with one that permits driving low-impedance modern speakers.

Power Supply: The power supply on the Model 28, shown in Figure 4, is quite interesting, in part because it was one of the major selling points of the radio, the first AC-powered sets having been released the previous year. At the time of release, however, AC voltage was still not well-regulated, so to deal with this issue, the primary of the power transformer has three taps for accepting AC voltages of 105 V_{RMS} , 115 V_{RMS} , of 125 V_{RMS} . A fancy plug assembly with three sockets and a plug connector allowed the user to select the closest tap to his/her specific AC voltage, guaranteeing the appropriate flux density through the iron core to generate the necessary secondary voltages.

The power transformer possesses of a total of five secondary windings. Using the numbering scheme found in Figure 4, secondary “114” supplies 1.5 VAC filament voltage for the four 26 tubes, secondary “115” supplies 2.2 VAC filament voltage for the 27 detector tube and pilot lamp, secondary “116” supplies the 5.0 VAC filament voltage for the pair of 71A tubes, and the center-tapped secondaries “117” and “118” are used along with the type 80 full-wave rectifier tube for supply B+ supply. This DC voltage, which was measured at approximately 320 V is smoothed by the ridiculously large pi filter composed of capacitors “102” and “103” and inductor “101.” Once this output voltage is run through the 5 k Ω resistor “111”, the final voltage presented to the portion of the set depicted in Figure 3 was measured at 92.8 V with a 1.2 V_{ppk} ripple.

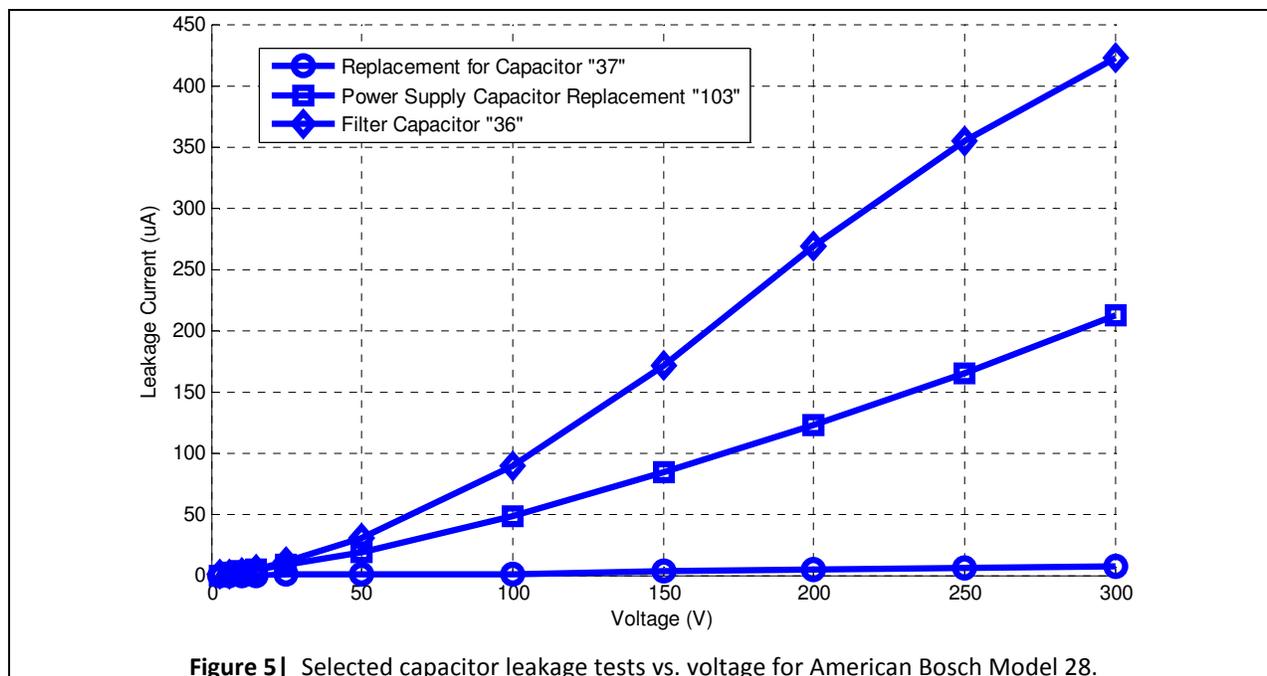
A total of nine capacitors (all but two of the entire set's capacitors with the exception of the mica neutralization capacitors) were found to be leaky at their standard operating voltages and replaced. The original Capacitor "37" was leaking a full 5 mA at its standard B+ operating level of 90 V, and had been replaced by a wax capacitor which was only slightly leaky over its operation range (shown below). Numerous other B+ filter caps were also faulty; the plot of capacitor "36" is shown in Figure 5 below. The smoothing capacitors "102" and "103" were both found to be significantly faulty at voltages above 50V. These two capacitors normally operate at 320 V in the set, so a previous user cut the leads from both capacitors and replaced the 2 μ F "103" with a gigantic 1 μ F paper capacitor which was little better when I tested it (shown below), having a leakage of >200 μ A at its standard operating voltage.

Figure 5 | Selected capacitor leakage tests vs. voltage for American Bosch Model 28.

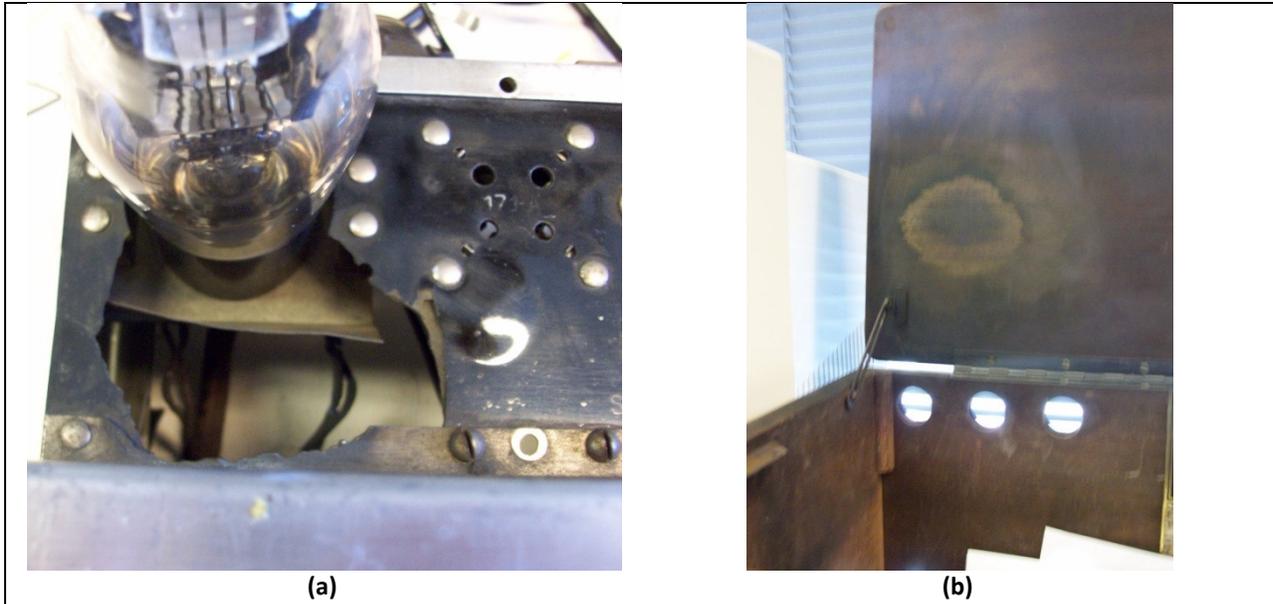
The specific Model 28 which I worked on experienced a significant fire at some point in its history. The definite cause of the fire is unknown, although the fact that it happened right at the location of the AC-voltage selector, leads me to hypothesize that the original filter capacitors across the mains, unlabeled in the schematic in Figure 4, located next to the AC-voltage selector switch and taps (“15”), became defective and at some point in time, perhaps twenty or thirty years after being built (or perhaps much sooner), someone turned on the set, one or both of the capacitors shorted to ground, caught fire, and consequently destroyed all components in the neighborhood.

The fire caused the set housing to become severely warped, as is visible in Fig. 6(a) below. This in turn caused one of the pin holders of the 71A tube to disconnect. I repaired this by inserting the tube into its mounting, placing the loose pin holder onto its appropriate position on the pin, and gluing it back to the chassis using Loctite 404 adhesive. After drying for 24 hours the bond was surprisingly sturdy.

Figure 6] Fire damage in the set occurred at the location of the original AC-voltage selectable switch in front of the rectifier tube. Significant damage to the power pack housing occurred (a) and evidence of the fire is clearly evident in the damage of the wood finish directly above the rectifier tube (b).

Limited repairs and modifications were made to the set by someone long before I came into possession of the radio in order to remedy the fire damage. With the AC-voltage selector switch destroyed, the 115 VAC tap had been hard-wired to the mains. In the course of my repairs I decided to change to the 125 VAC tap just to be on the safe side. The original repair person also replaced the 5 k Ω resistor used for setting the B+ voltage with a 300 Ω Candohm resistor (by the Muter Co.) Why this choice of resistor was made is beyond me because it resulted in a 300 V plate voltage, which is beyond the maximum ratings of some of the tubes. I re-replaced this resistor with a proper value and I made further repairs and replacements to the fire-damaged wire-resistors at the output of the secondary taps.

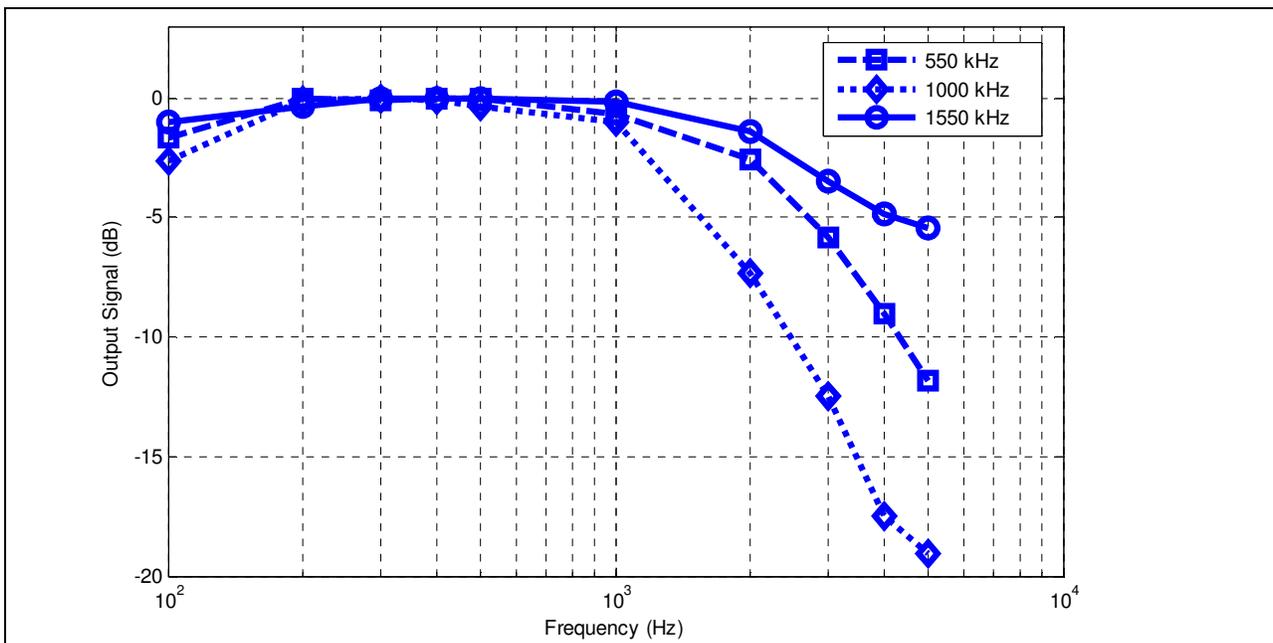
With the set running, a loop antenna was placed nearby and transmitted AM-modulated tones at frequencies of 550 kHz, 1000 kHz, and 1550 kHz. The results are plotted in Figure 7 below. It is interesting to note that while overall, the circuit does not have very good frequency response, it varies significantly depending on RF, performing much better at the extremes of the tuning range than at the middle of the AM band.

Figure 7] Frequency response of the Model 28 at the AM frequencies of 550 kHz, 1000 kHz, and 1550 kHz.

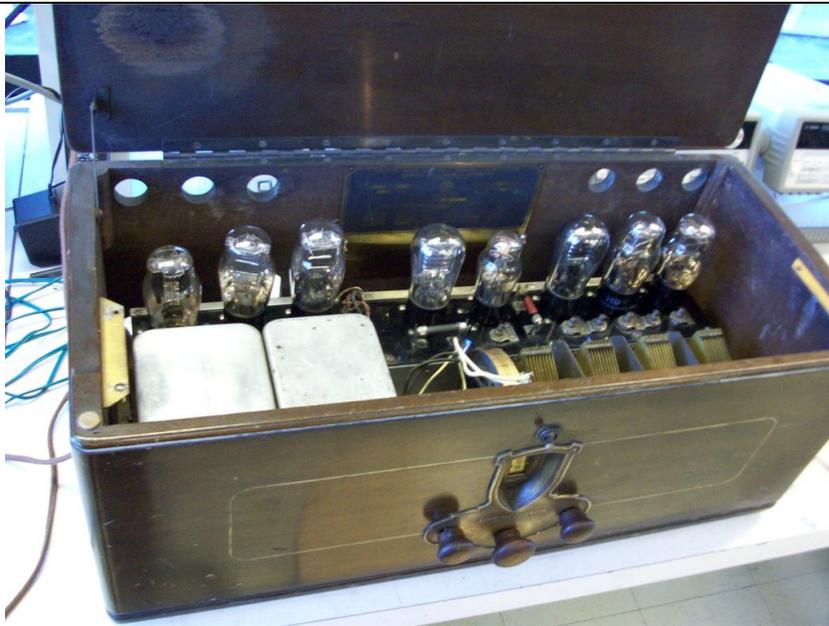
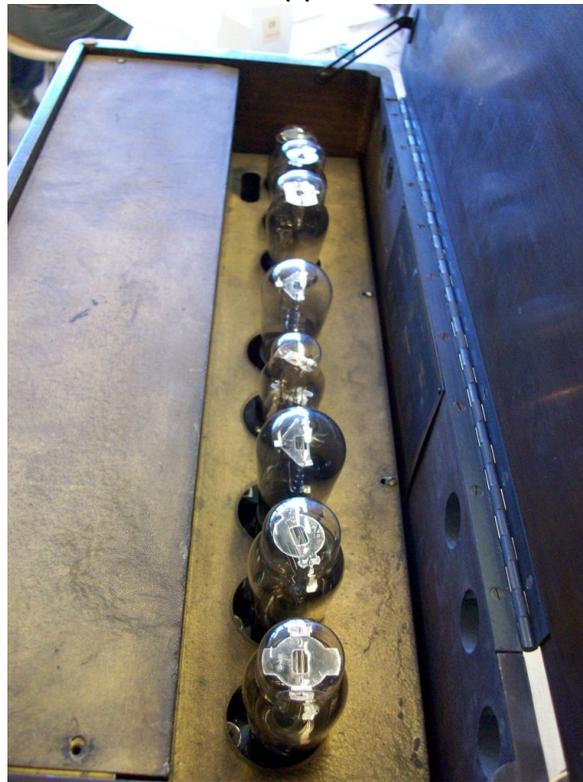
Figure 9 | The Model 28 mounted in its mahogany case with all electronics exposed (a), and with its cover/shield in place (b).

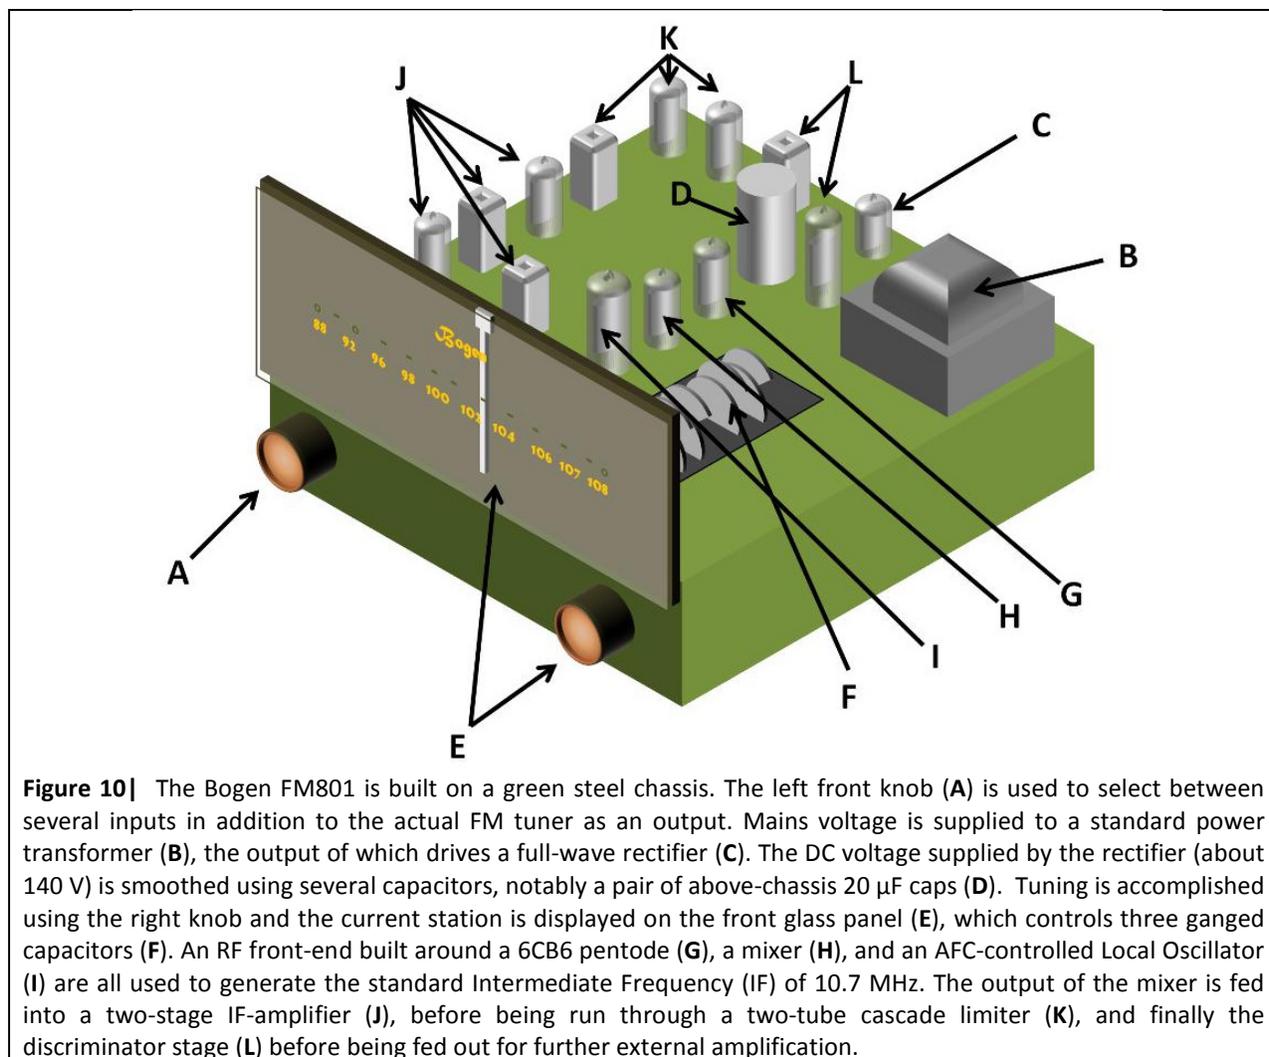
Figure 10| The Bogen FM801 is built on a green steel chassis. The left front knob (A) is used to select between several inputs in addition to the actual FM tuner as an output. Mains voltage is supplied to a standard power transformer (B), the output of which drives a full-wave rectifier (C). The DC voltage supplied by the rectifier (about 140 V) is smoothed using several capacitors, notably a pair of above-chassis 20 μ F caps (D). Tuning is accomplished using the right knob and the current station is displayed on the front glass panel (E), which controls three ganged capacitors (F). An RF front-end built around a 6CB6 pentode (G), a mixer (H), and an AFC-controlled Local Oscillator (I) are all used to generate the standard Intermediate Frequency (IF) of 10.7 MHz. The output of the mixer is fed into a two-stage IF-amplifier (J), before being run through a two-tube cascade limiter (K), and finally the discriminator stage (L) before being fed out for further external amplification.

Twenty-four tumultuous years after the American Bosch Model 28 was released, David Bogen & Co., (founded in 1932), released their FM801 Tuner⁴. The set, consisting of nine miniature glass tubes, in an open chassis, is depicted in Figure 10 above for clarity. Photographs are found in sections below. In a 1953 Allied Catalog, the tuner sold for \$115. As a point of reference, a new car would have cost around \$1500 to \$1700 in 1953. By the time the FM801 was being produced in 1952, Bogen was a well-respected manufacturer of high-end and reliable radios and PA systems.

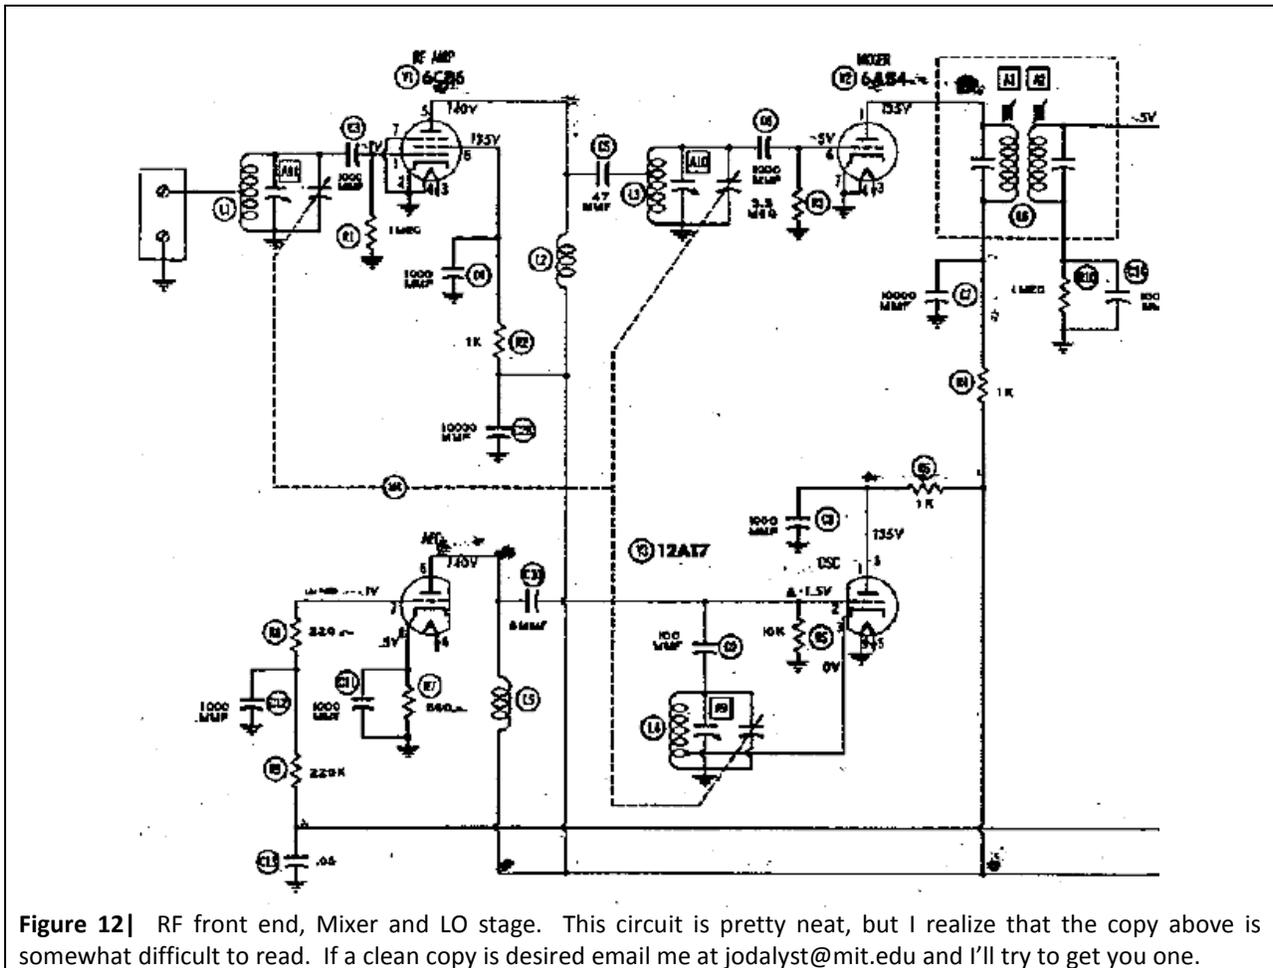
Figure 12| RF front end, Mixer and LO stage. This circuit is pretty neat, but I realize that the copy above is somewhat difficult to read. If a clean copy is desired email me at jodalyst@mit.edu and I'll try to get you one.

Mixer: The output of the RF amp is filtered once more through a second tuned stage before being applied to the grid of the 6AB4 high- μ triode. The triode is biased using space-charge accumulation on its grid (which is why its cathode can be grounded). While not clearly shown in the schematic, the LO signal is supplied to the mixer circuit through the inductive coupling of coils L3 and L4 which are aligned in close proximity in the layout of the set. The output of the mixer provides the signal at the IF of 10.7 MHz.

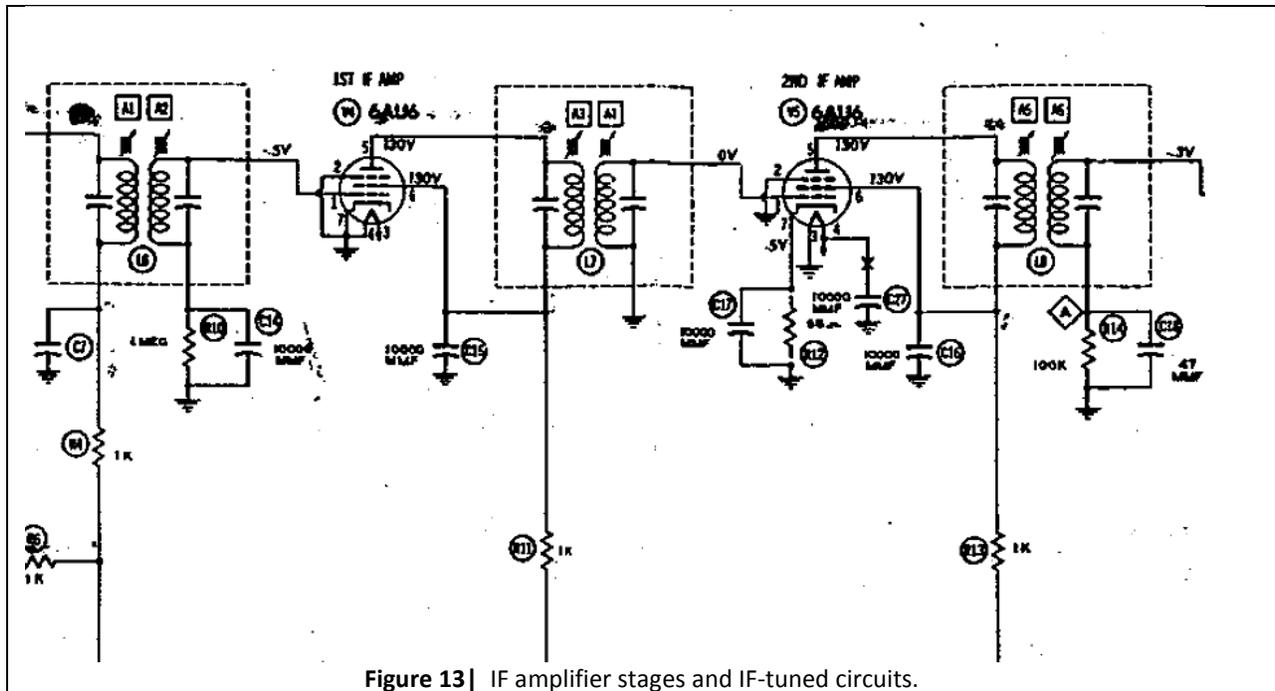
Figure 13 | IF amplifier stages and IF-tuned circuits.

IF Stages: A total of six IF-tuned circuits exist as well as two 6AU6 pentodes used for IF amplification. The tuned circuits are contained within three cans (two circuits each) and tuned using a flat-head screwdriver from above for one circuit and below for the other. The first IF amplifier is biased using space charge accumulation on the grid (grid voltage = -0.5 V and cathode voltage = 0V), most likely to provide the highest gain early on, since this would be advantageous (however miniscule) for keeping noise levels down. The second IF amplifier has its cathode connected to a bypassed 68 Ω resistor such that its grid voltage = 0 V and its cathode is at 0.5 V. Consequently both IF tubes have the same grid-cathode voltage of -0.5 V.

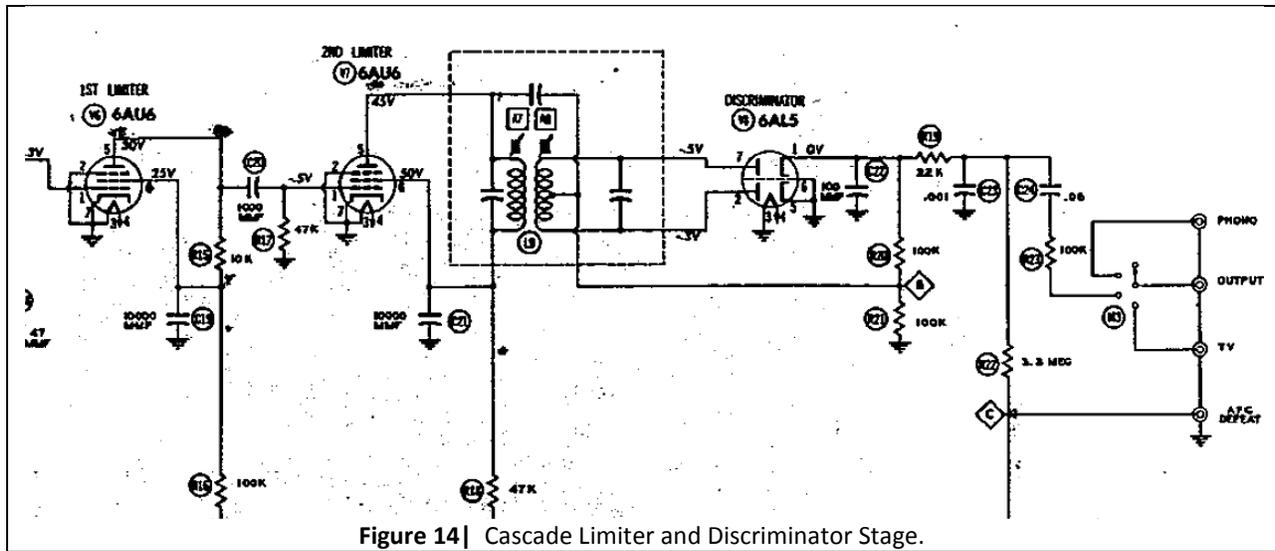
Limiters: As shown in Figure 14 below, the output of the IF amp stages feeds into a two-stage cascade limiter, constructed of two 6AU6 triodes running at significantly lower plate voltages (30 V plate, 25 V screen grid for Limiter 1 and 45 V plate, 50 V screen grid for Limiter 2). The rationale for these lower voltages is so that the tubes saturate at normal signal strengths rather than only with large signals; we want the tubes to saturate because that is what causes the limiting.

Figure 14 | Cascade Limiter and Discriminator Stage.

Discriminator: A 6AL5 dual diode tube is used as the core of the discriminator circuit shown in Figure 14 above. The only real departure from a traditional discriminator layout is that a single capacitor to ground is used to tie the cathodes of the two diodes together rather than a pair of capacitors each tied to the feedback voltage (the “B” inside the diamond). Incrementally this really doesn’t make a difference, although there may be some hidden functionality which I have yet to comprehend. The AF signal is run through a RC low-pass filter with corner frequency of approximately 7.2 kHz before being sent out on its way to an external amplifier. The AF output is also run through an additional RC low-pass filter (3.3 MΩ, 60 nF, corner frequency 5 Hz), which is subsequently used to provide the AFC control signal.

While at first I thought the usage of two limiters a bit extreme and even...dare I say, wasteful...I researched the circuit and discovered that there is indeed a reason to the madness. The limiter tubes are biased at Q-points that are close to saturation. Ideally signals fed into the limiter are very large, and will be limited on both their positive and negative half-cycles. However, if the input signals are small, such as those that would come from a weak station, only the positive half-cycle of the signal would get limited. The negative half-cycle would drive the limiter stage more into its linear region of operation, which is something we don't want.

If, however, you take the output of the first limiter and then feed that into a second limiter, the 180° phase inversion resulting from the common-cathode configuration of the first stage, will now allow the second limiter to saturate on the untouched half-cycles from the first stage. As a result, the cascade of limiters provides full-cycle limiting for both strong *and* weak signals, something that a single limiter stage cannot do.

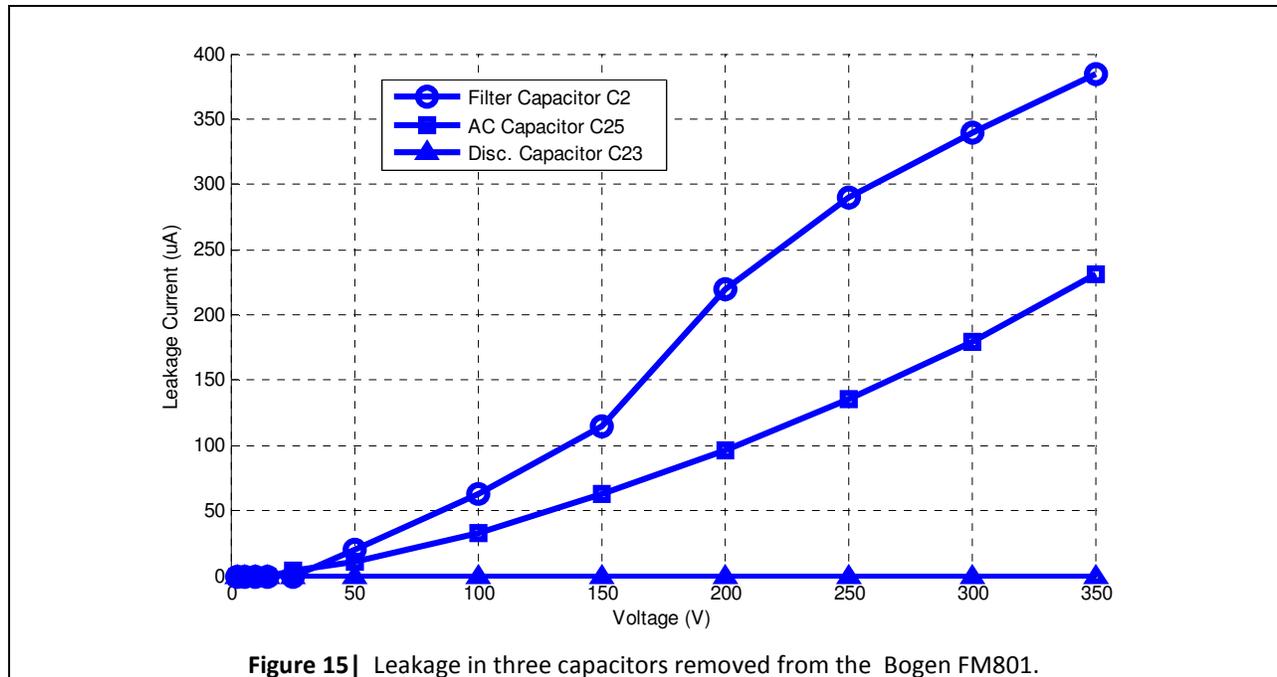
Unlike the sorry state of affairs in the American Bosch Model 28, most capacitors in the Bogen FM801 were fine. The only exceptions to this were the three smoothing capacitors at the output of the power supply and the filter capacitor located across the mains. A selection of the capacitors and their leakage ratings are depicted in Figure 15.

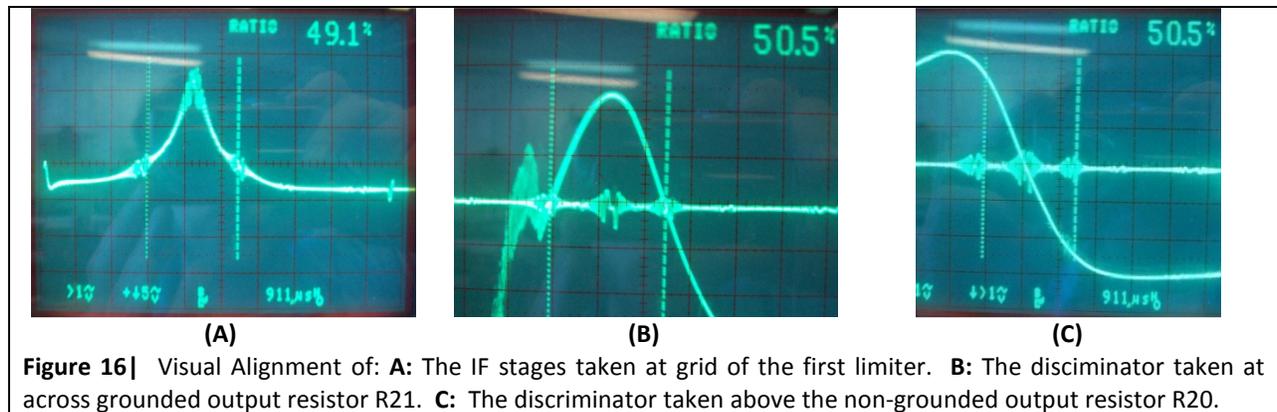
The set was visually aligned over the course of about five hours of learning and trial-and-error sessions. Visual results of the alignment are depicted in Figure 16 below. After alignment, reception on the set was significantly improved.

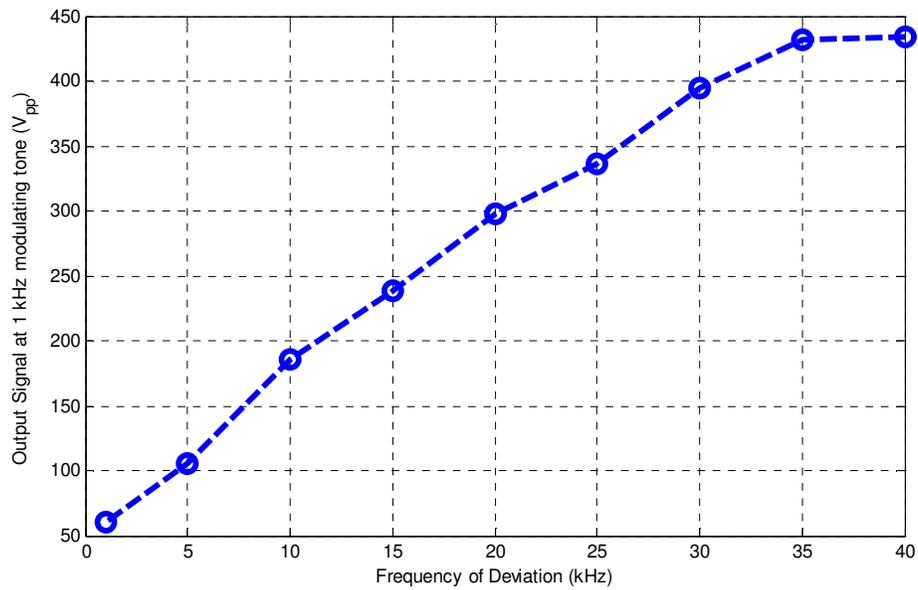
With the set properly aligned, a signal generator was hooked up to the grid of the first IF amplifier, and a 10.7 MHz FM signal was used to test the audio characteristics of the set. Figure 17 depicts the output signal strength vs. frequency deviation, with the set seeming to max out at +/- 35 kHz deviation.

Figure 17] Plot of signal strength vs. frequency of deviation for 1 kHz tone. Above 35 kHz, the receiver did not generate a louder output.

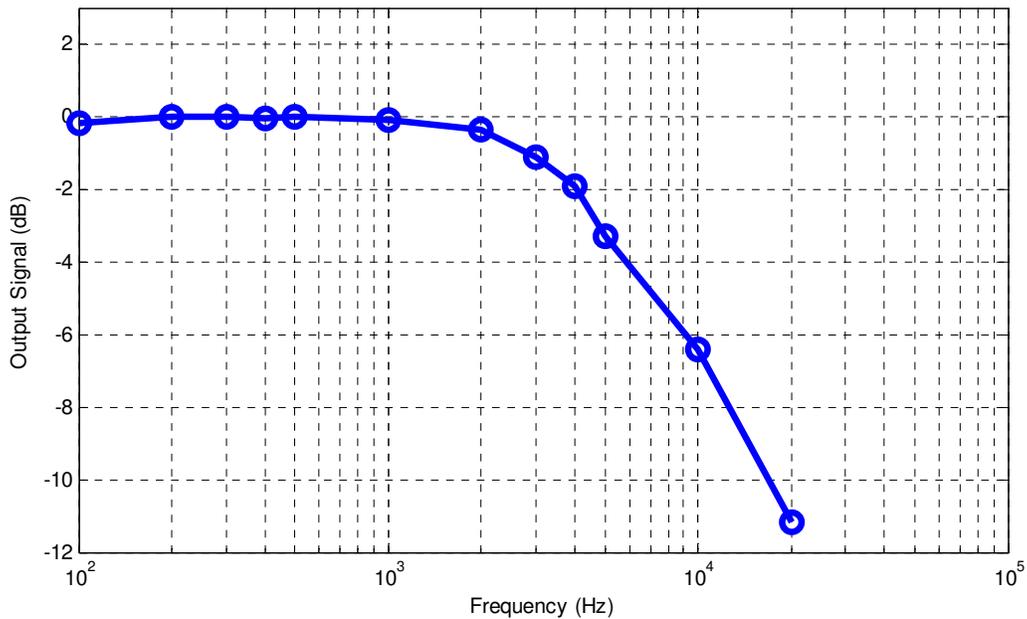
The audio frequency response for a +/-25 kHz signal is shown in Figure 18. The -3dB point occurs just shy of 5 kHz, which truth be told, is not that impressive. I think I'm going to try and remove the RC low-pass filter right at the output of the discriminator since its corner frequency of 7.4 kHz is not helping the situation.

Figure 17] Frequency response of the Bogen FM801 taken at the phono plug output. The signal is down approximately 3.5 dB at 5 kHz.
